TS-590SG Cooling Fan Fix

Gary - AC6EG

The cooling fans in some recently produced TS-590SG transceivers were inadvertently installed backwards. The fix is simple and straightforward, but please proceed at your own risk.

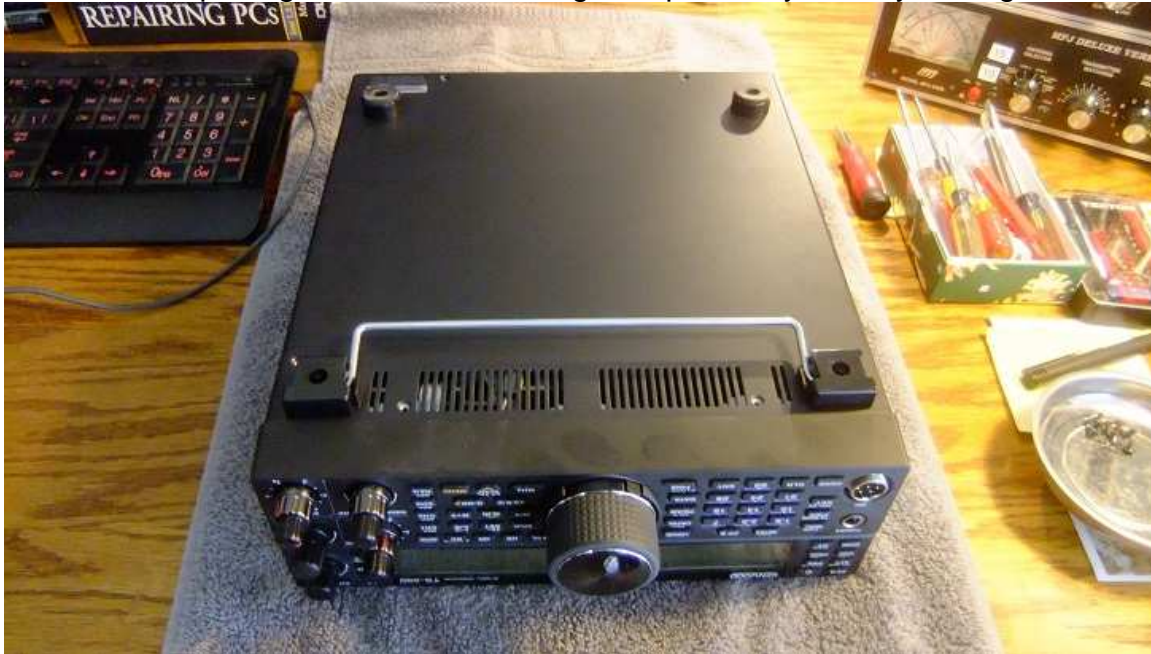
Begin by removing the 10 screws on the bottom & sides of the case.

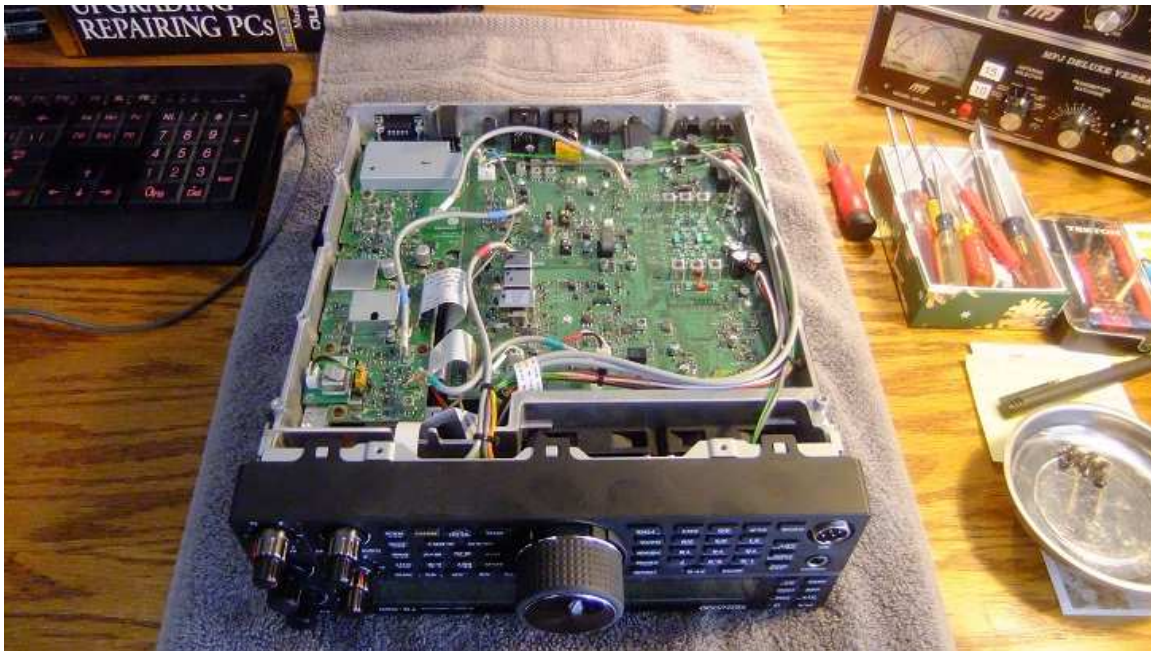
Remove the bottom case.

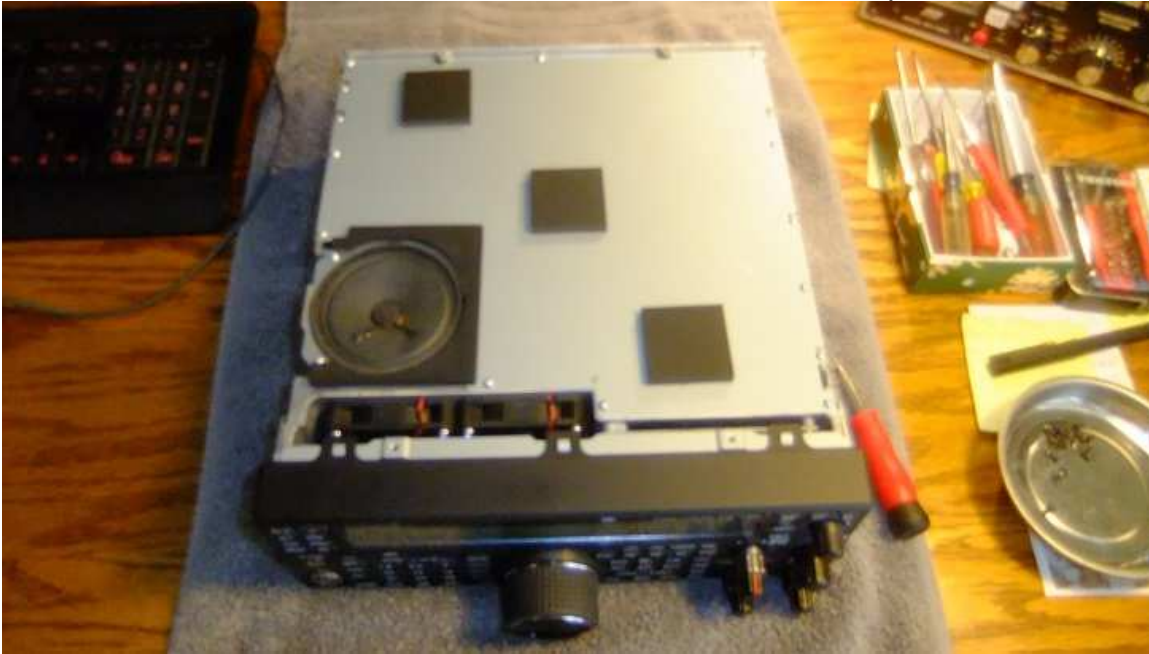
Turn the radio over, remove four more screws and lift off the top case:

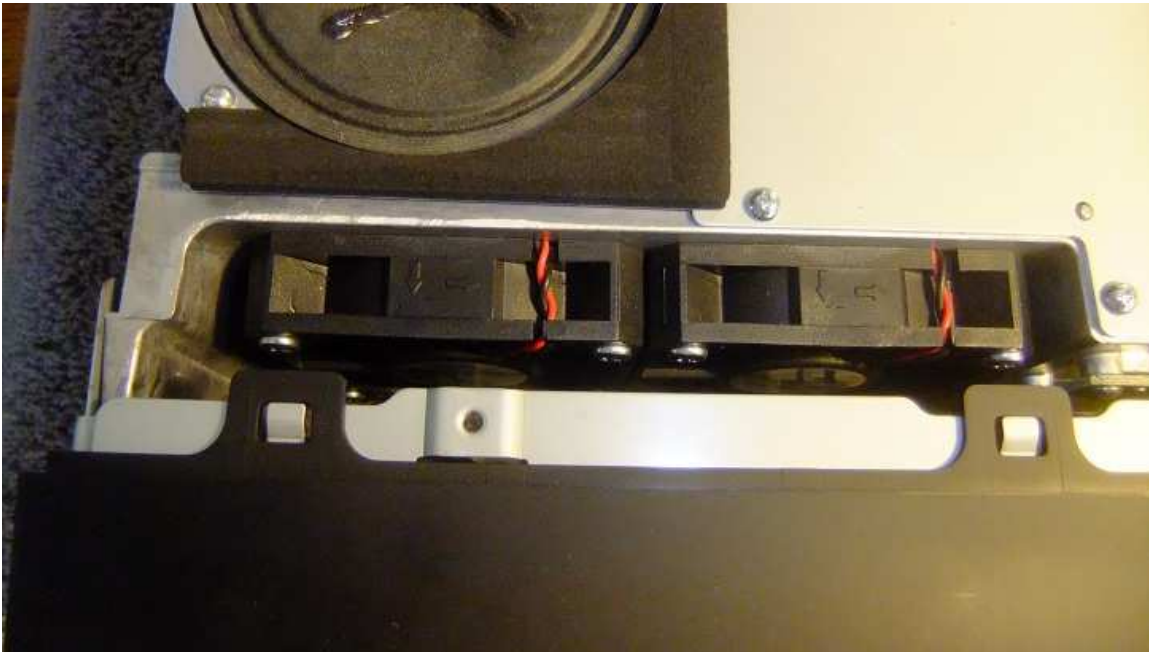
Arrows embossed on these two cooling fans show air flow is incorrectly directed toward the front of the radio:

Remove the fan mounting screws and carefully lift the wires out of the notches in the fan frames. Turn the fans around and reinstall them with the air flow arrows pointing toward the back of the radio.

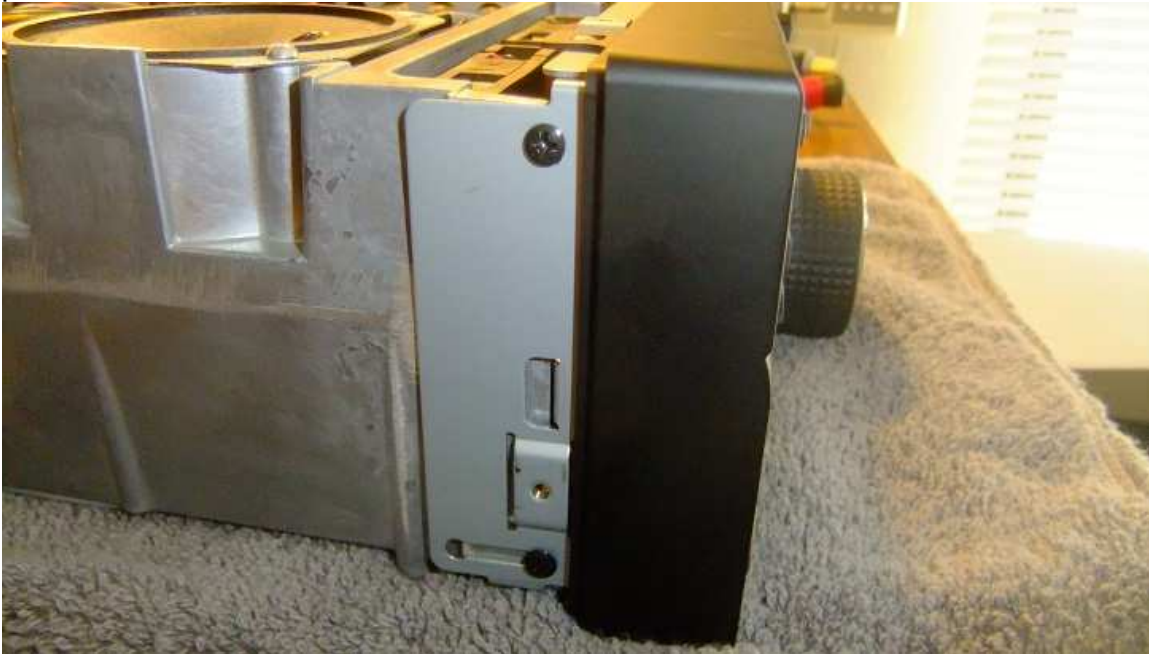
Loosen the bottom screws and remove the top screws at the sides of the front panel. Do not remove the bottom screws.

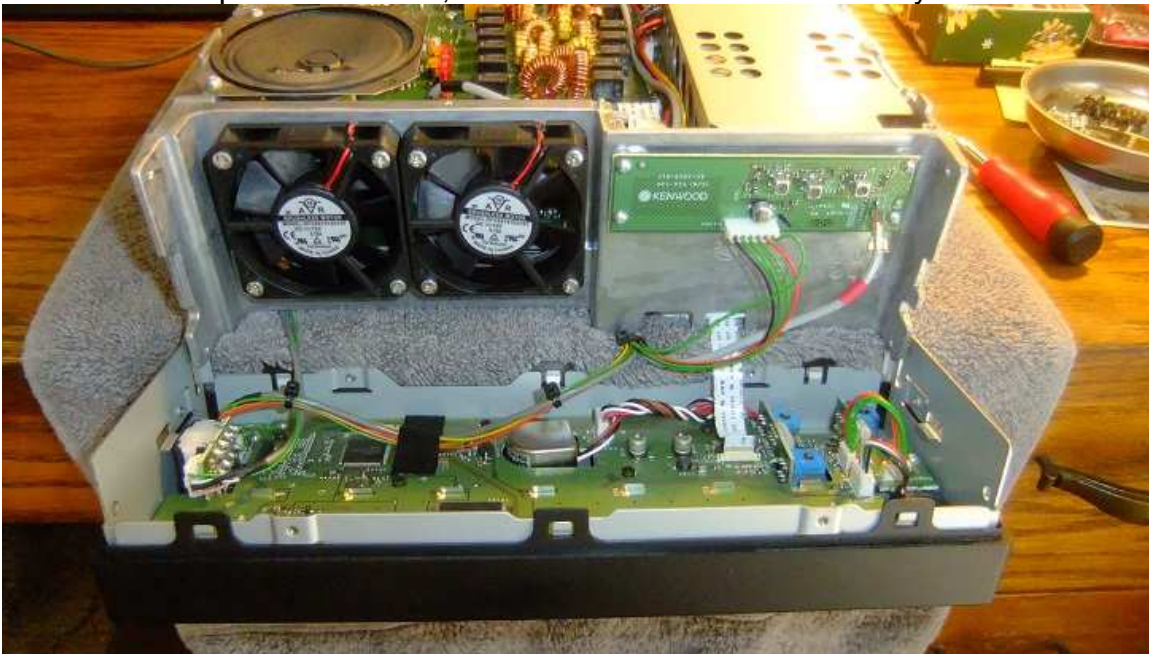
Allow the front panel to tilt down out of the way over the edge of table or workbench. You do not need to disconnect any wires. I removed the sheet metal shield on the top of the chassis, but found that was not necessary.

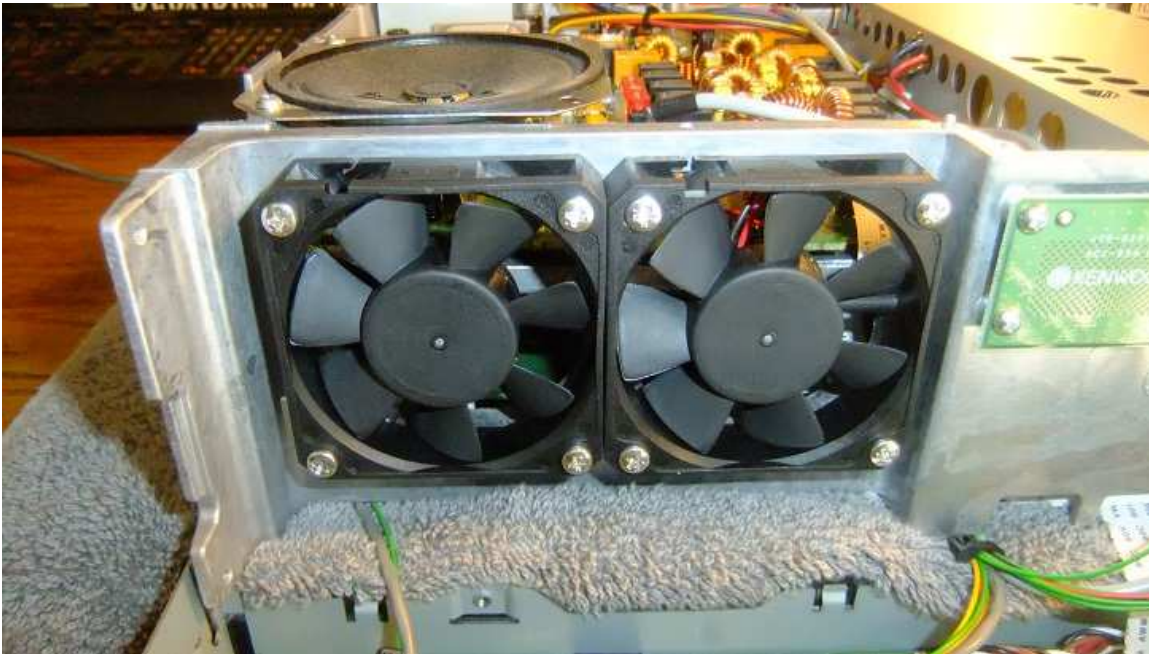
When you are done, the fans should look like this. Make sure the wires are clear of the fan blades:
